RE: Preliminary Assessment Report for the Procino Plating site (DE-0344)

PRELIMINARY ASSESSMENT OF PROCINO PLATING

DE-0344 October 2010

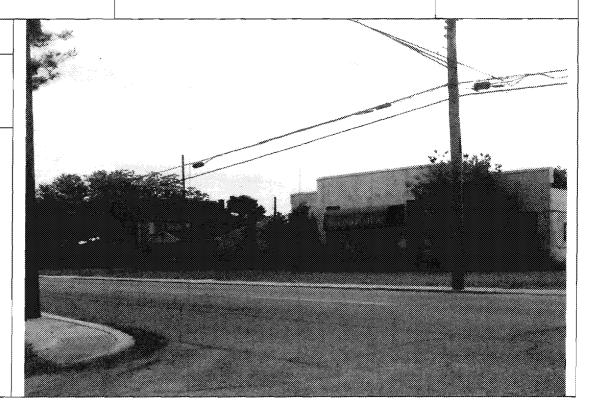
Building front of Procino Plating facing Market St.

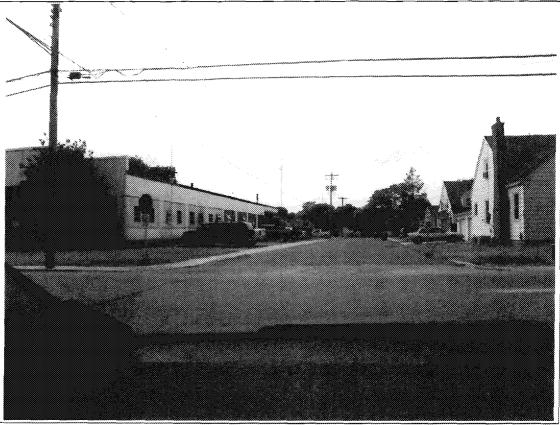
The side of the Procino Plating building and parking lot along 9th Street.

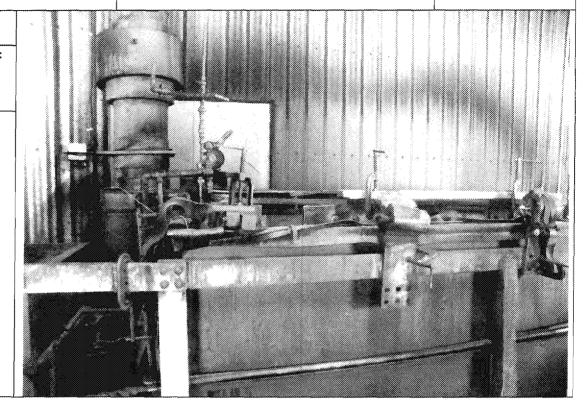
An operating electroplating bath.

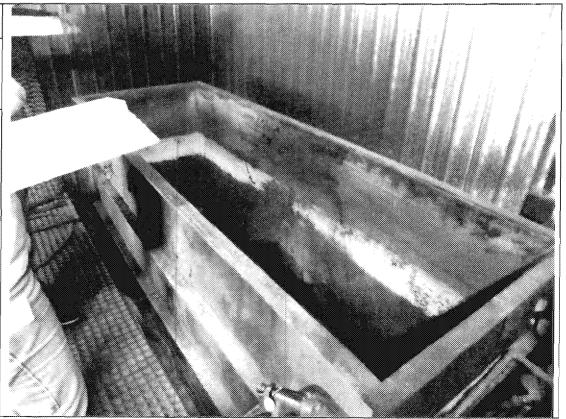
An empty electroplating bath ready for operation. Both baths are on a platform.

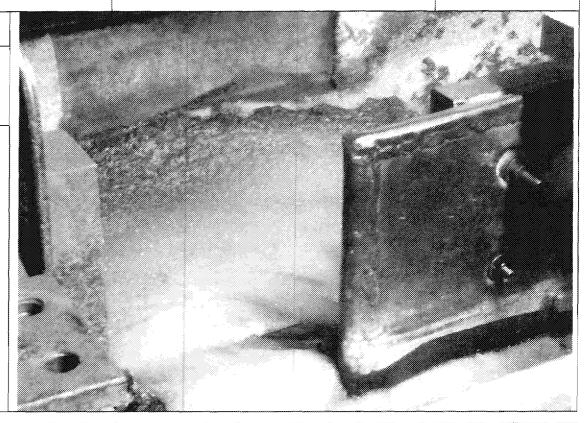
Orange foam that formed on top of the acid bath while a metal slab is heated and soaked in the bath.

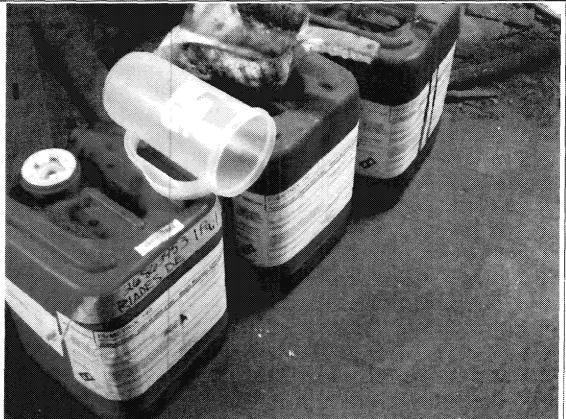
Containers of an additive used in the acid baths during the electroplating process.

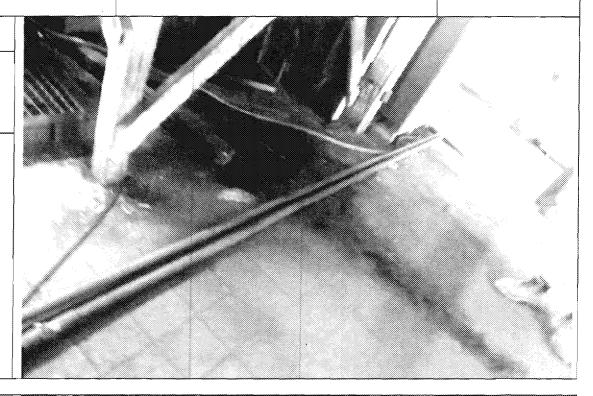
A substance observed leaking from the acid bath

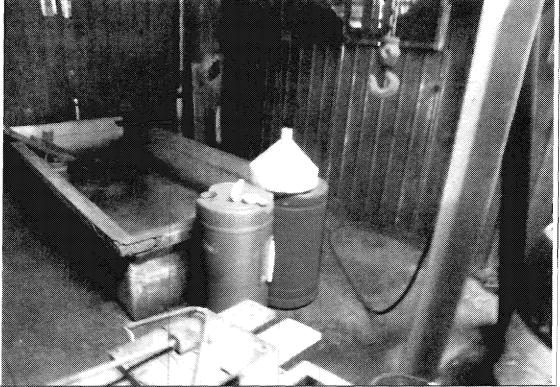
A tub and solutions used in the electroplating process.

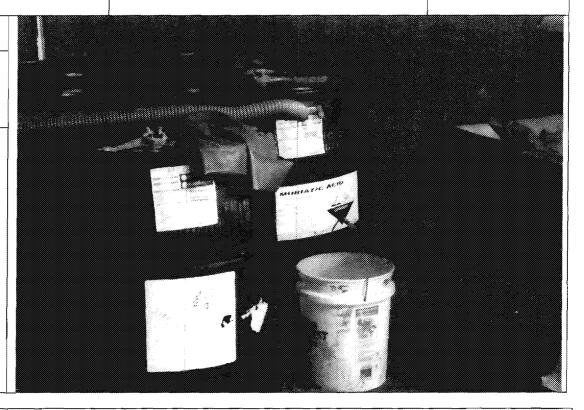
Drums of solutions

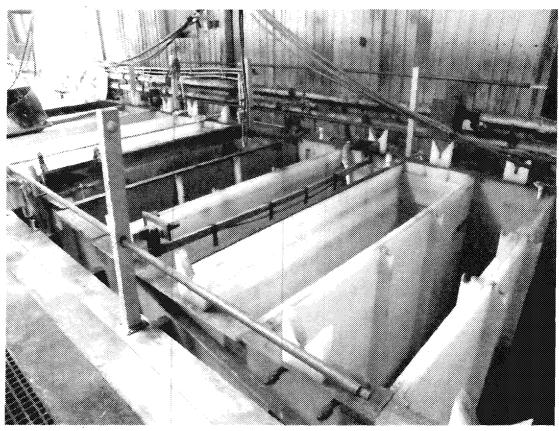
Empty and decommissioned acid baths.

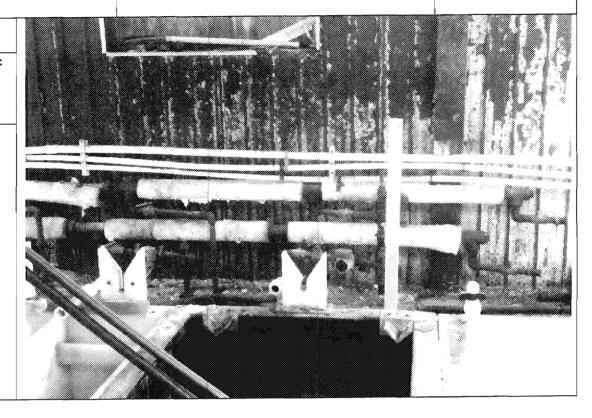
Piping for the decommissioned acid baths mounted to the walls.

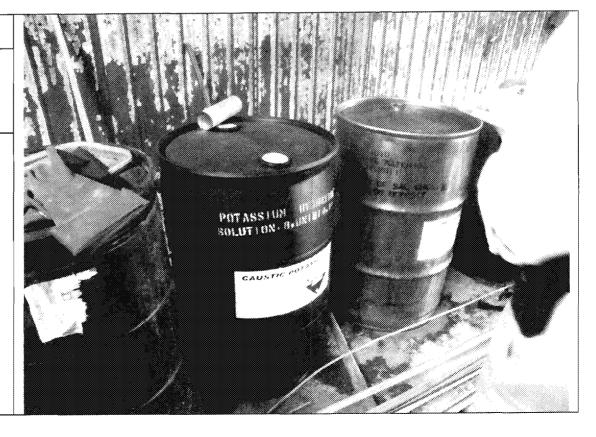
Drums of caustic solutions.

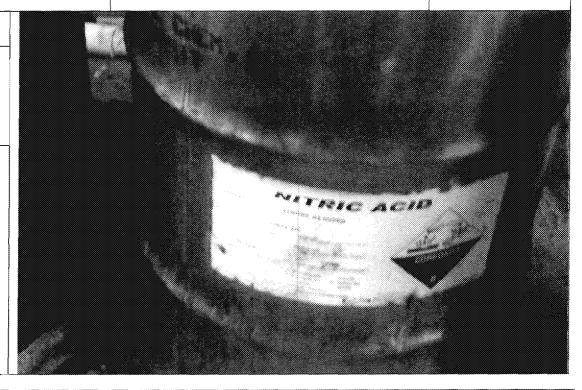
Drum of Nitric acid

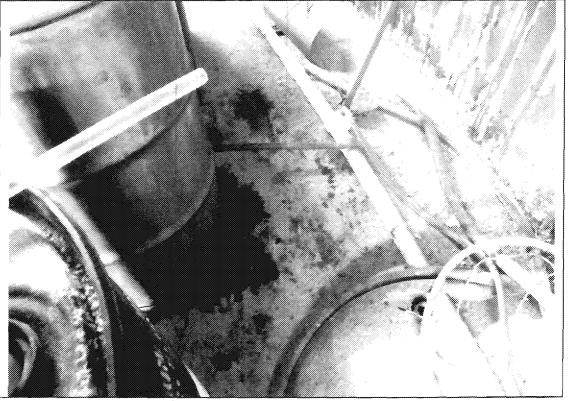
Staining under the drum of Nitric Acid.

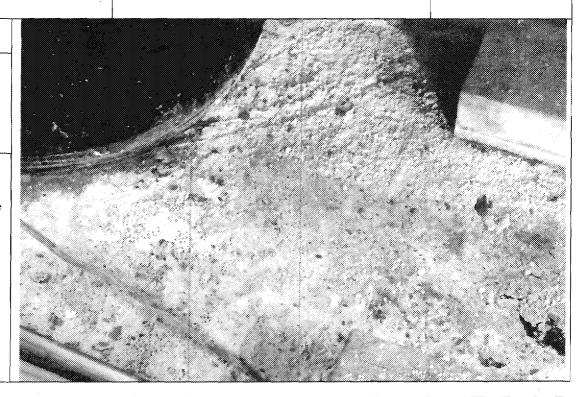
Yellow and white powdery substance on the floor around drums.

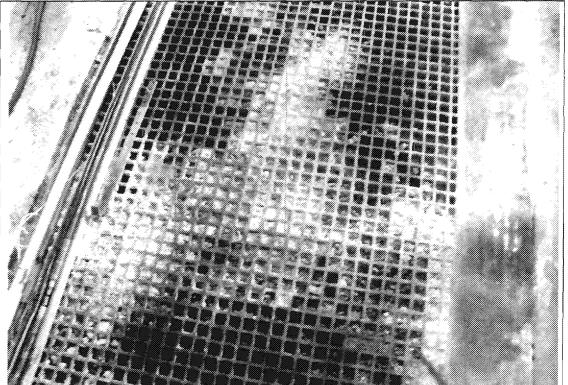
Yellow and white powdery substance in a metal grate walkway.

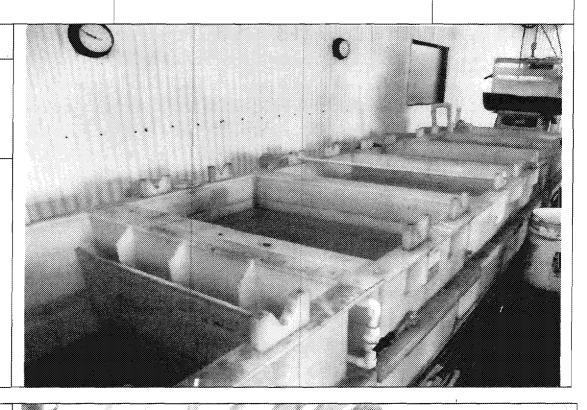
Water cooling tanks for the current electroplating operations.

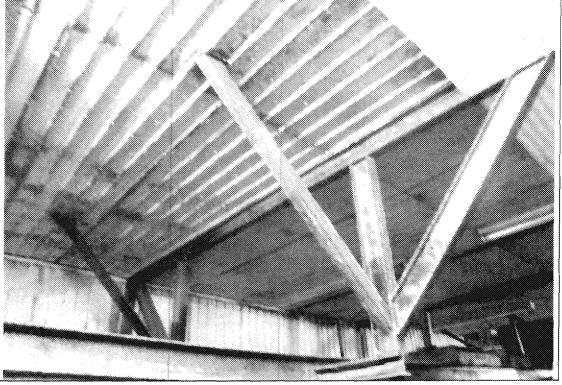
Photo No. 18

Rusted steel beams above the former acid baths.

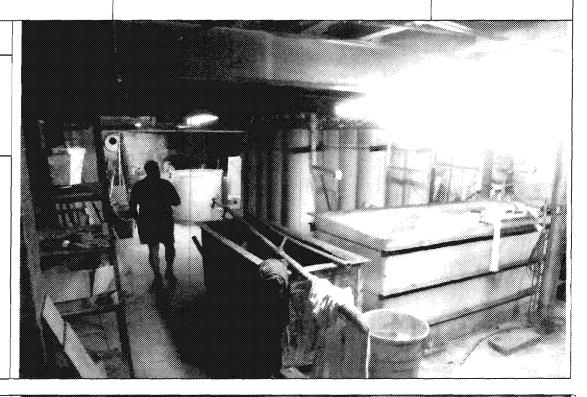
Basement of the main building on Site.

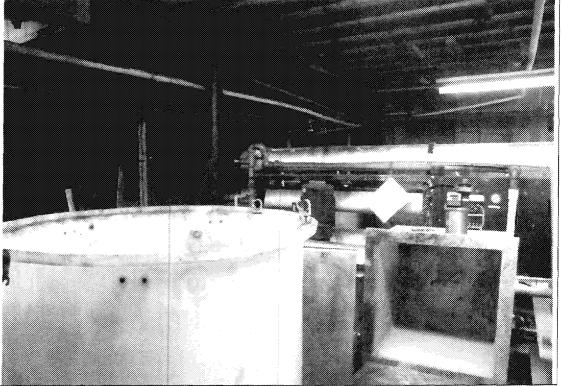
Photo No. 20

Dismantled electroplating equipment placed in the basement for storage.

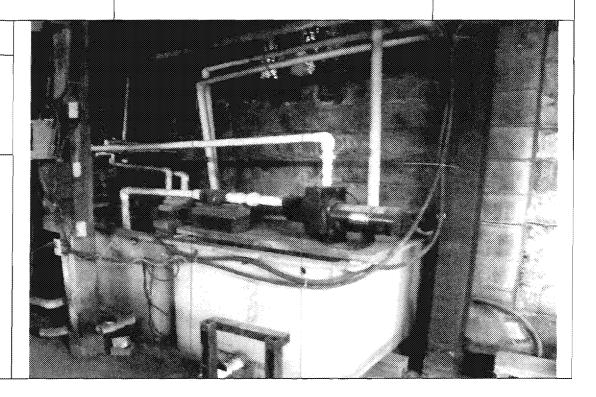
Pretreatment water system

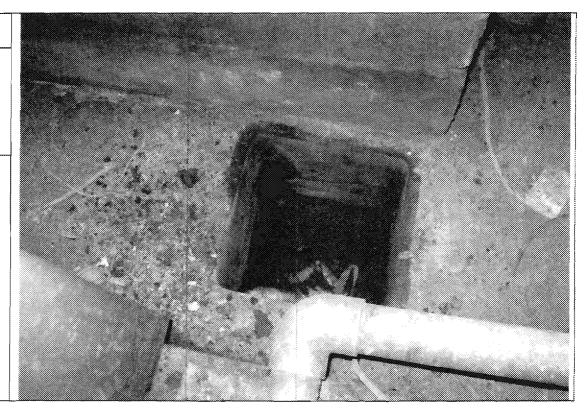
A suspected sump or well located in the basement.

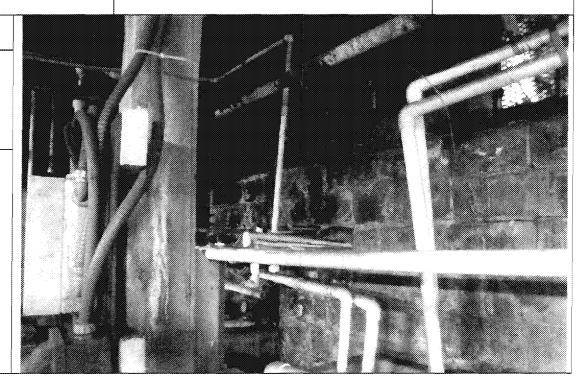
The pretreatment piping

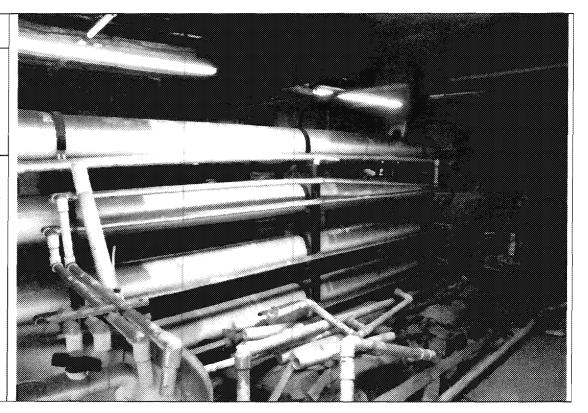
Photo No. 24

A reverse osmosis system used in the pretreatment of solutions before going through the onsite water treatment.

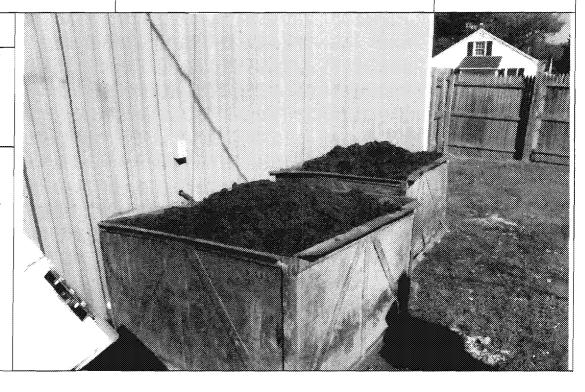
Large uncovered metal bins with metal shavings.

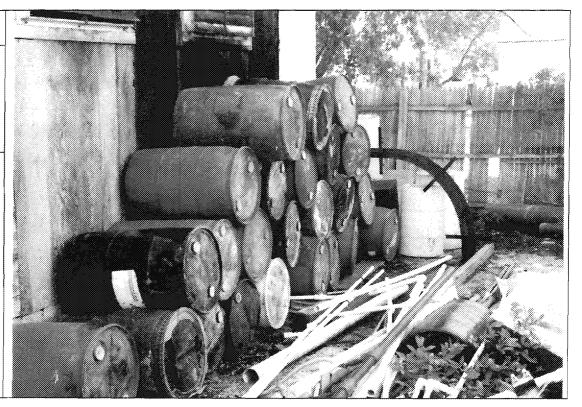
Photo No. 26

The outdoor cross space between the two buildings was used for storage of mostly empty drums and containers of metal shavings from the cutting process.

Empty drums stored in the cross space area between the two buildings onsite.

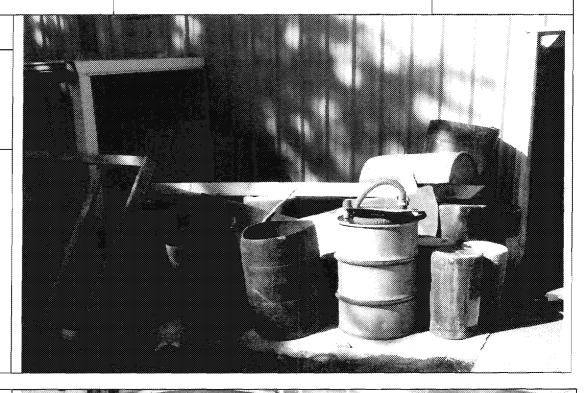
Drums in the cross space area.

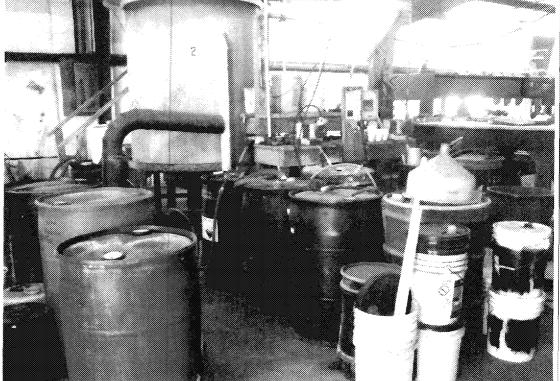
Photo No. 28

Drums of chemicals used in the pretreatment of the metal slabs.

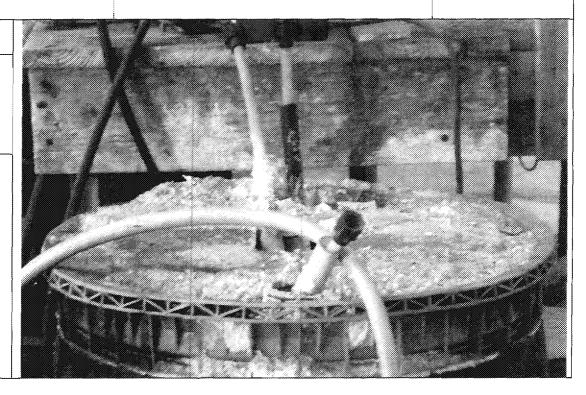
A drum with a white substance on top and around it and piping connected to a larger mixing tank.

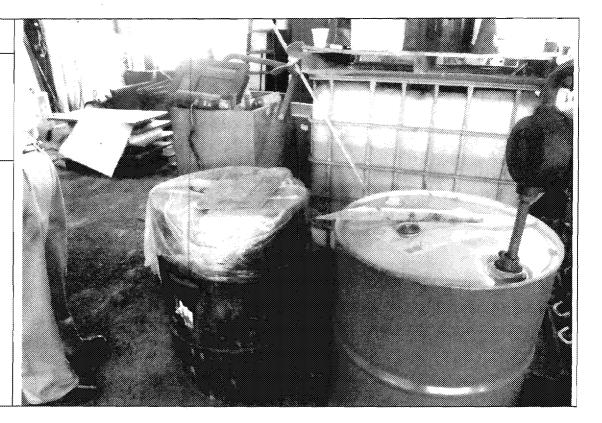
Unlabeled or incorrectly labeled drums stored in the second building.

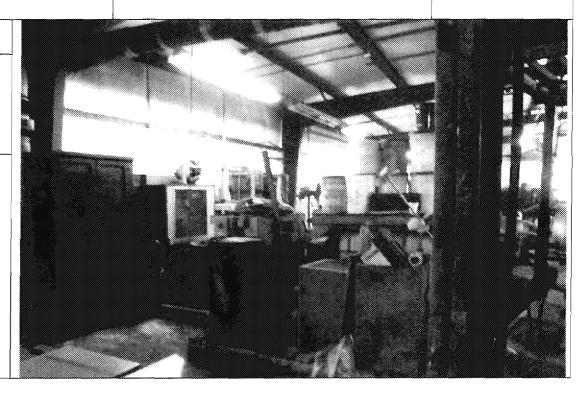
Unlabeled or incorrectly labeled drums and other equipment in the storage area in the second building.

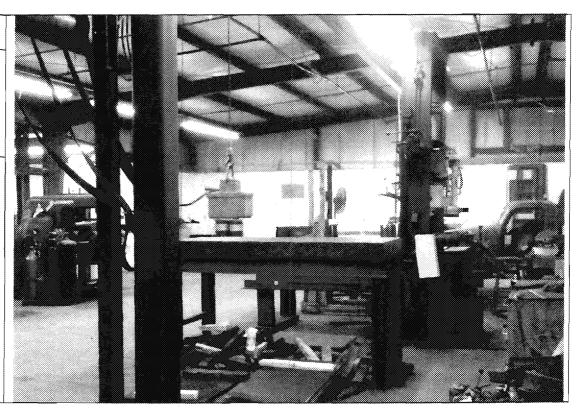
Equipment used to cut and shape the metal slabs.

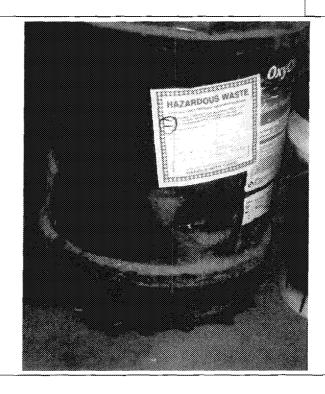
A leaking drum labeled hazardous waste.

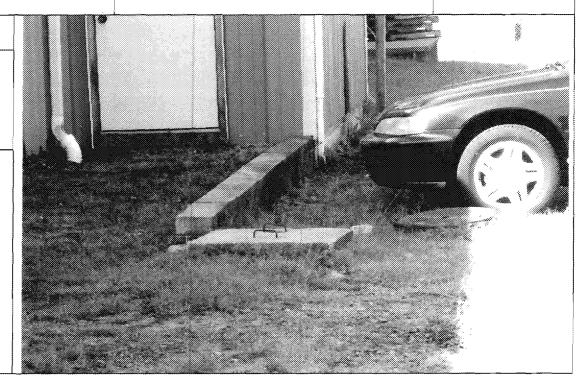
Well cover outside the second building on the Site.

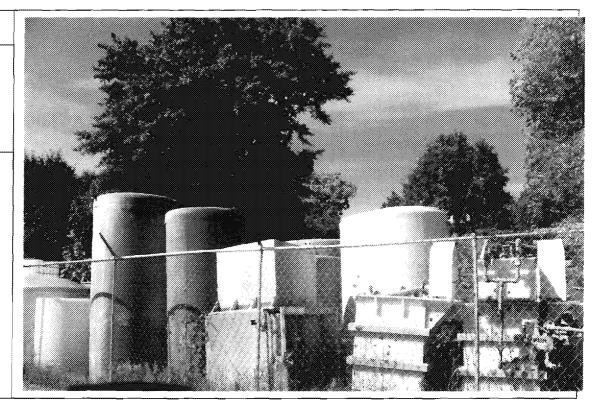
General outdoors storage area onsite.
